Escalating Coastal Erosion

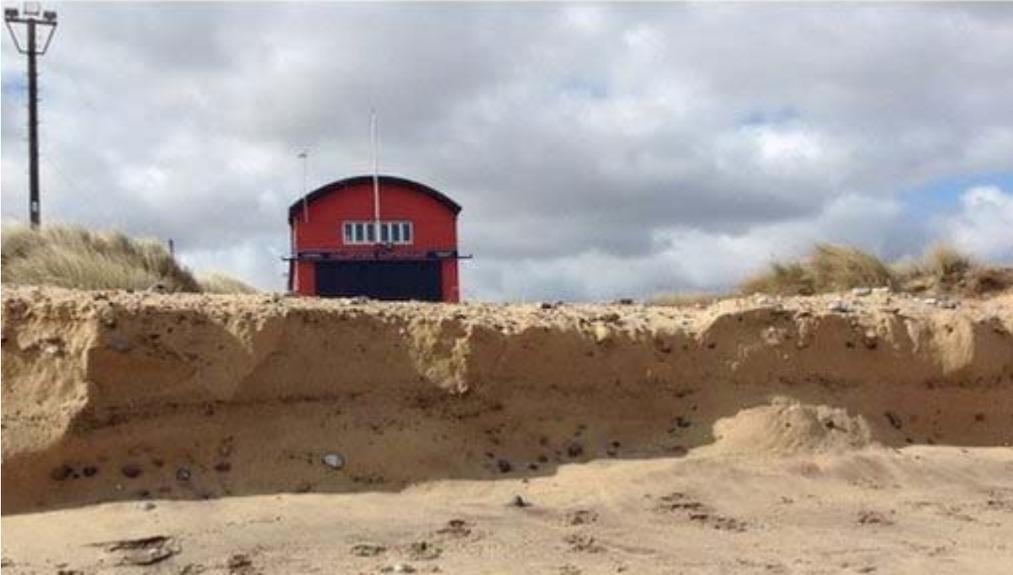
Above, the Caister Lifeboat housing, now left with a sheer three metre drop to the sand stripped beach.

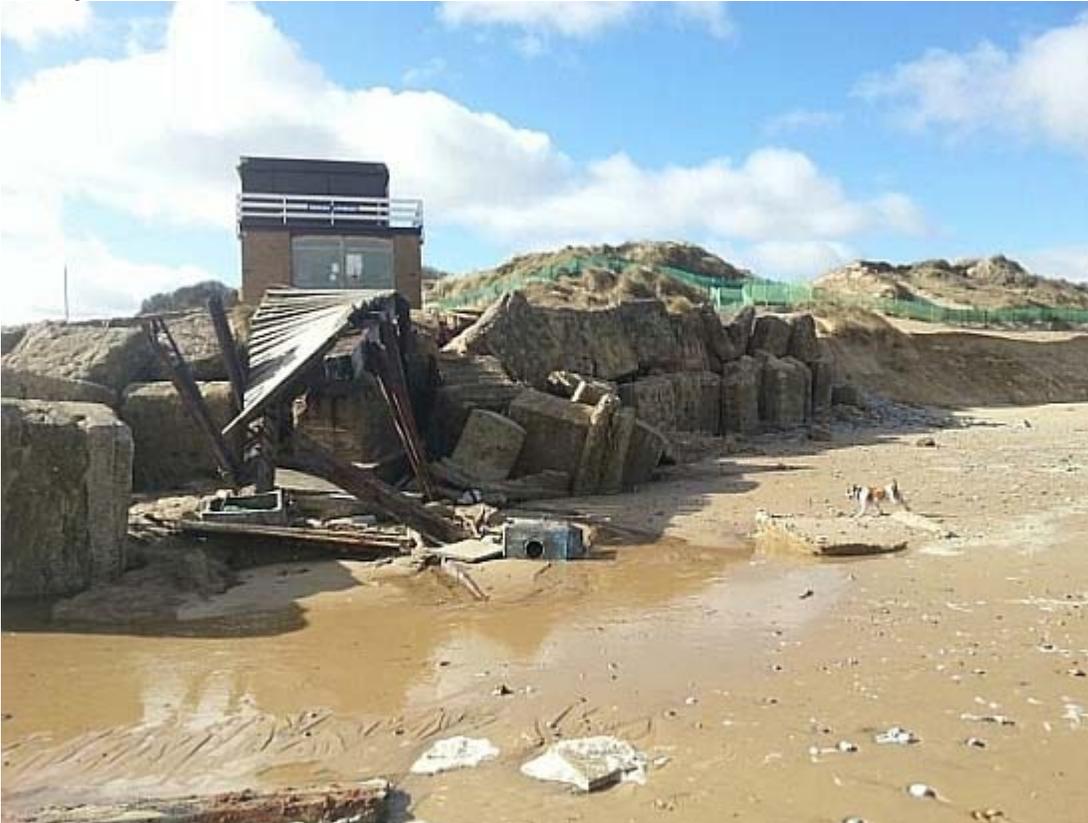
Below, what remains of the Hemsby ILB launch ramp, where the huge concrete blocks and heavy ex-railway sleepers forming the slope have been undermined and tossed aside by wave power.

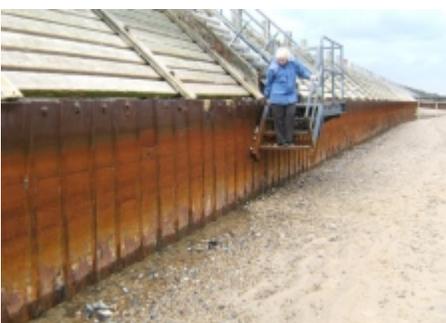
Below, the remains of the Hopton Beach, its access steps left dangling in the air since the beach was stripped of most of its sand. Access is currently impossible.

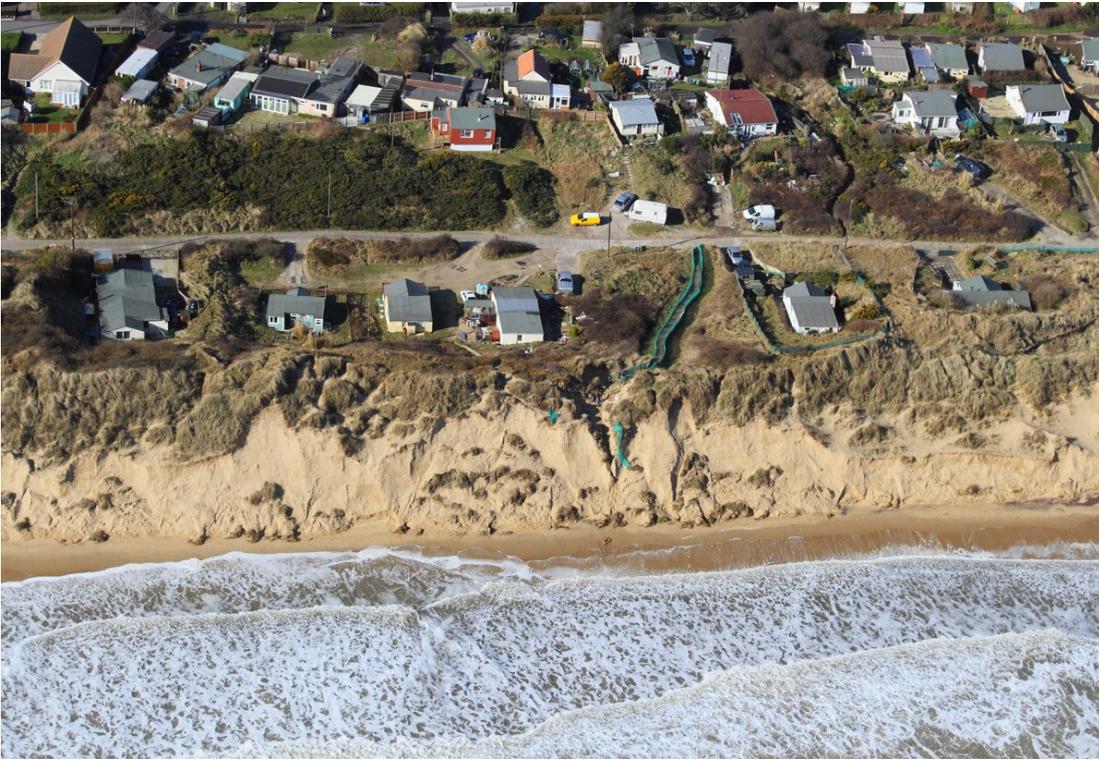
Above are some of the bungalows now 'on the edge' at Hemsby South Marrams (South of Hemsby Gap) People are living in them full time (!) The dune face will fall to a 40-45 degree slope over the next month placing them even more 'on the edge' if not over it.

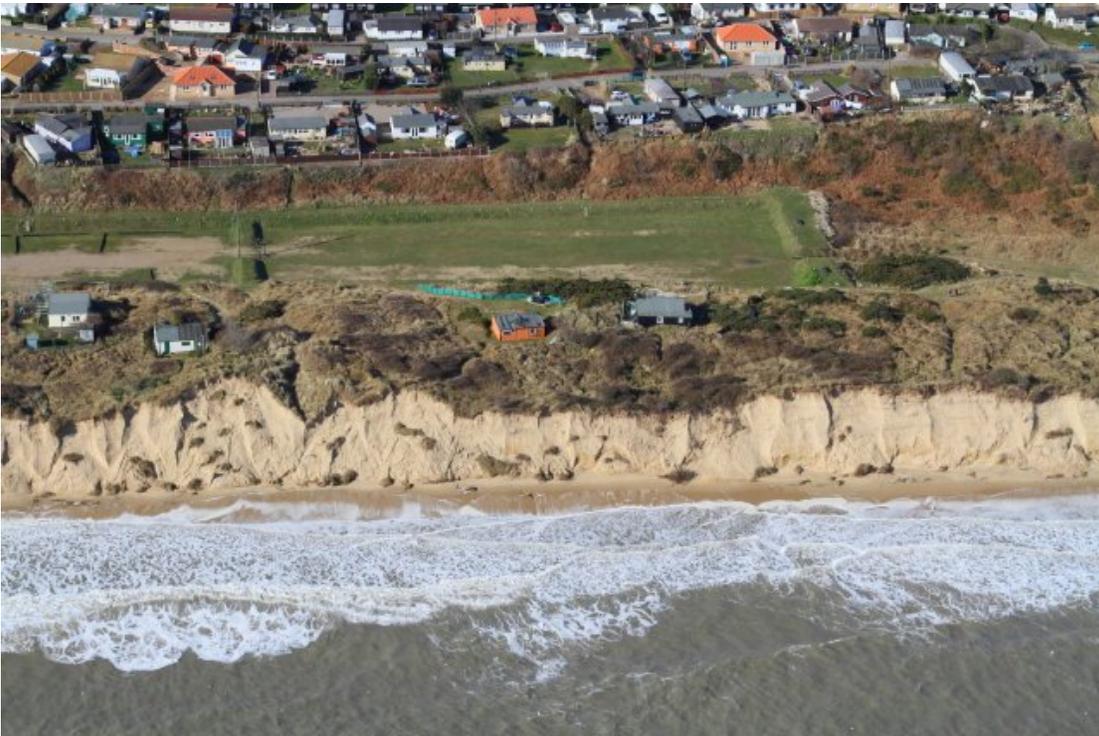
Above, the threatened bungalows at Hemsby North Marrams to the north of Hemsby Gap. The second bungalow from the left, that closest to the rapidly eroding dune front is Pat Gowen's G3IOR/A summer residence.

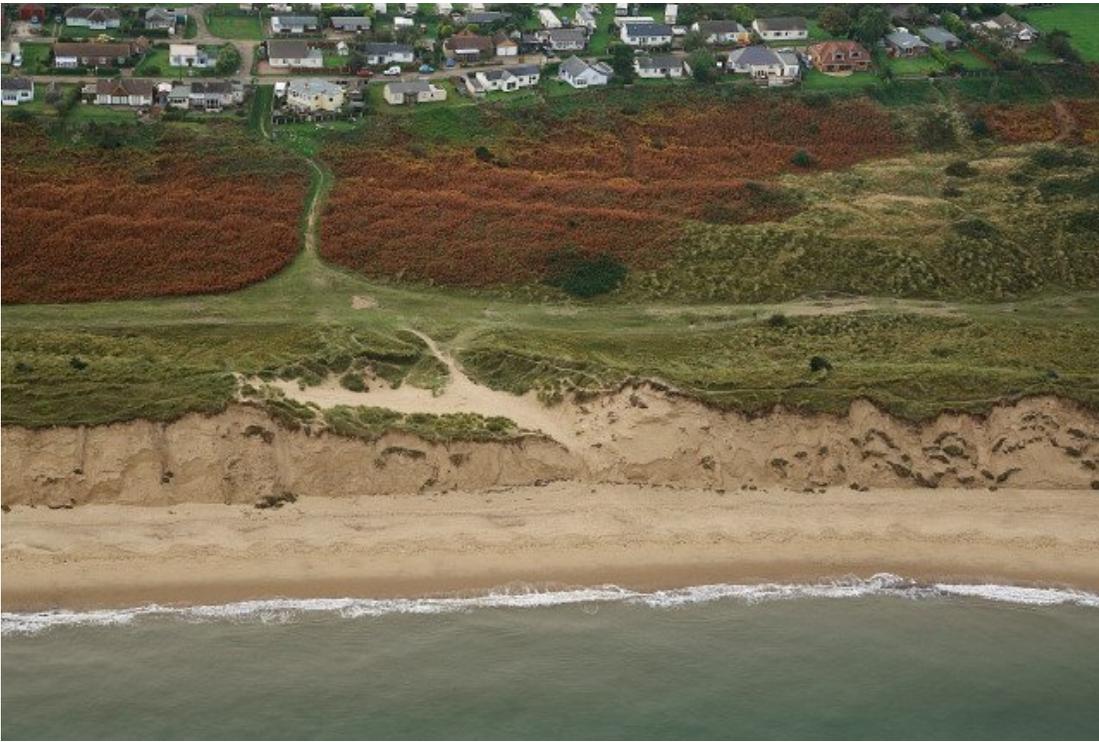
This photo below shows the 1945 WWII V2 crater once over 100 metres back from the dune edge. It formed a delightful sun-trap out of the wind for day trippers. Now the sea is about to break through to flood the entirety of the Great Winterton Valley. Once the beach itself, this accreted forming a quadruple high dune frontage until three years following the commencement of commercial scale offshore aggregate dredging when erosion first commenced.

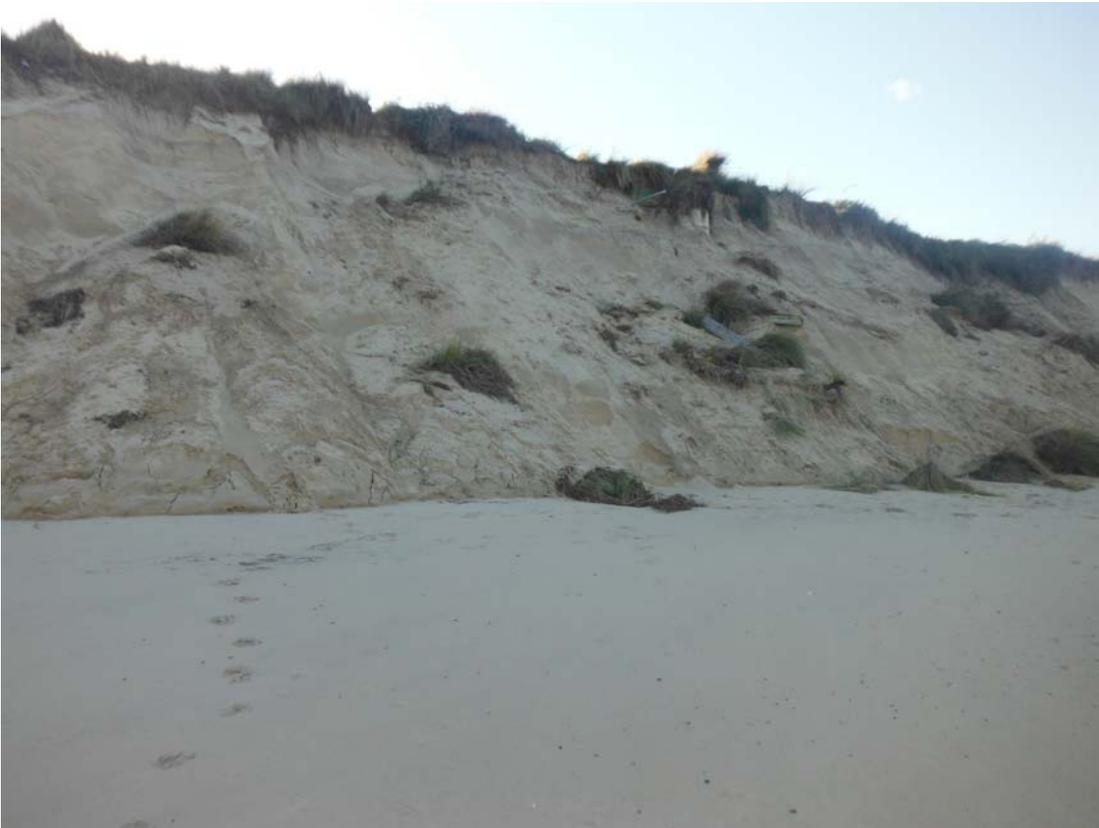
All along the coast from Caister to Winterton-on-Sea, a favourite walk for many, the dune face is now cut back to a 5 - 6 metre high vertical, impossible to climb. If a freak wave or sudden sea rise suddenly results, there is no escape from the beach and a high likelihood of being covered by sand if one attempts to scramble up the dune face.

This will eventually destabilise as it dries out to reform a 40 – 45 degree slope, until the next major high tide with high waves further erodes the base to reform another vertical dune front set further back.

The picture below, mid way between Hemsby Gap and Winterton shows the face there beginning to slip.
